Assessment of Wear and Corrosion at the Taper Junction of Modular Total Hip Replacements

A dissertation submitted to the University College London in fulfilment of the
requirements for the degree of

Doctor of Philosophy

*Assessment of Wear and Corrosion at the Taper Junction of
Modular Total Hip Replacements
Doctor of Philosophy in Musculoskeletal Sciences
A. Panagiotidou, UCL, 2017*

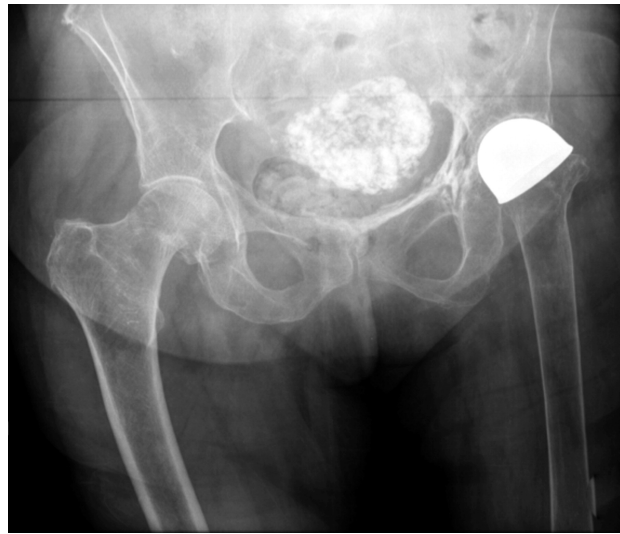
Figure 2-2: Anteroposterior pelvic radiograph depicting a left hip vitallium mould arthroplasty*.

The evolution of the hip replacement continued with the vitallium mould arthroplasty (1938) (Figure 2-2), the acetabular cup and femoral head resurfacing by Wiles (1938) (Figure 2-3) and the acrylic femoral head replacement by doctors Jean and Robert Judet (1940) (Figure 2-4).

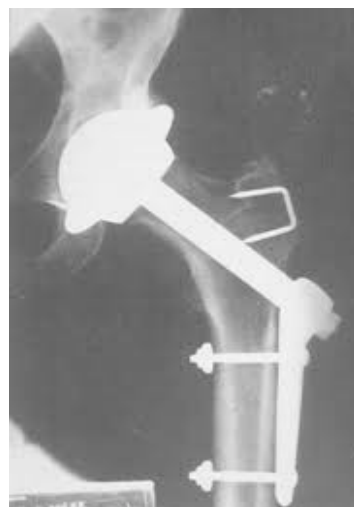
Figure 2-3: Anteroposterior radiograph depicting a left acetabular cup and femoral head resurfacing by Wilest.

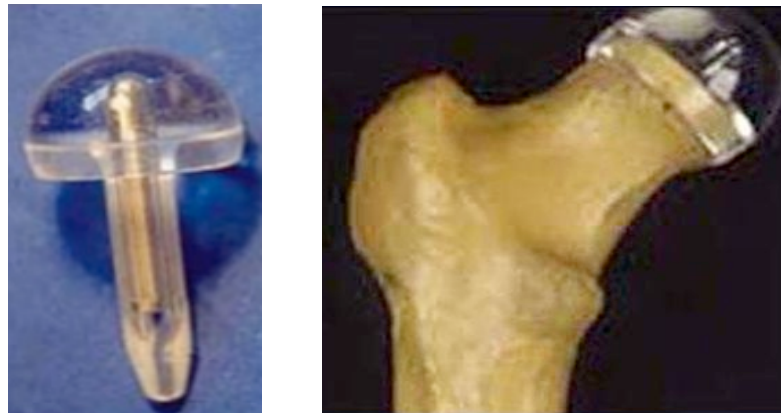
Figure 2-4: The Judet hemi hip acrylic arthroplasty featuring a distinctive flared collar below the head and a vertical intramedullary stem *.

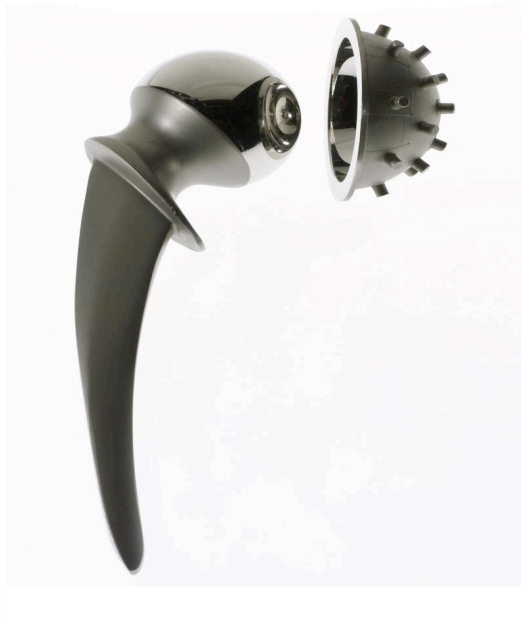
Figure 2-5: The McKee & Farrar MoM monobloc hip replacement.*

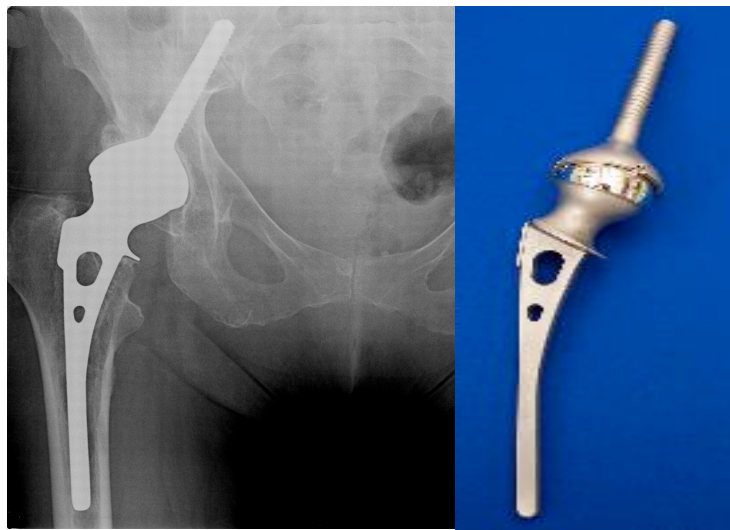
Figure 2-6: The Ring prosthesis, a large-bore monoblock MoM hip replacement.†

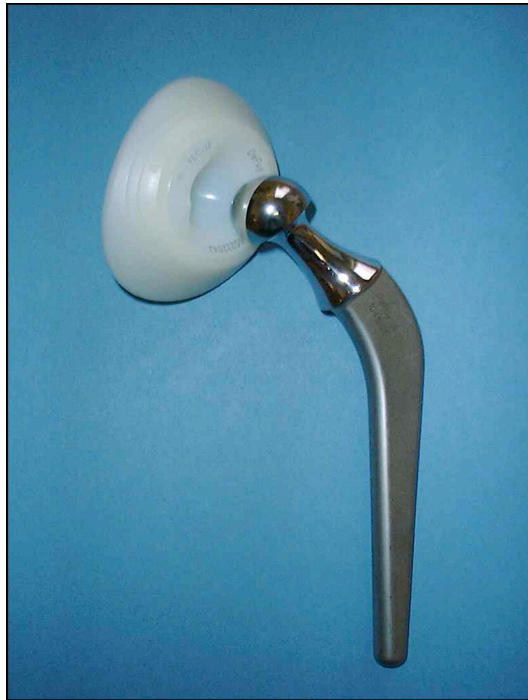
Figure 2-7: The Charnley MoP monobloc hip replacement.*

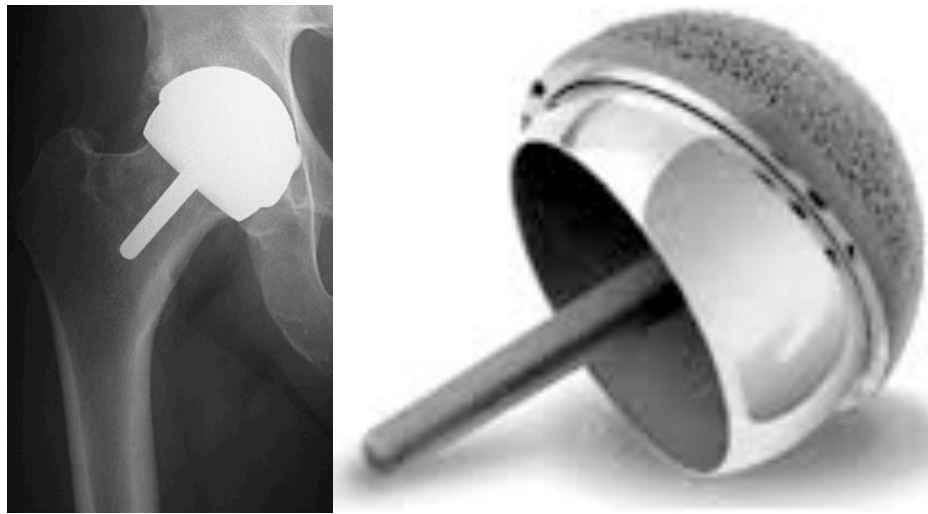
Figure 2-9: Anteroposterior radiograph showing a BHR in situ and the prosthesis itself.*

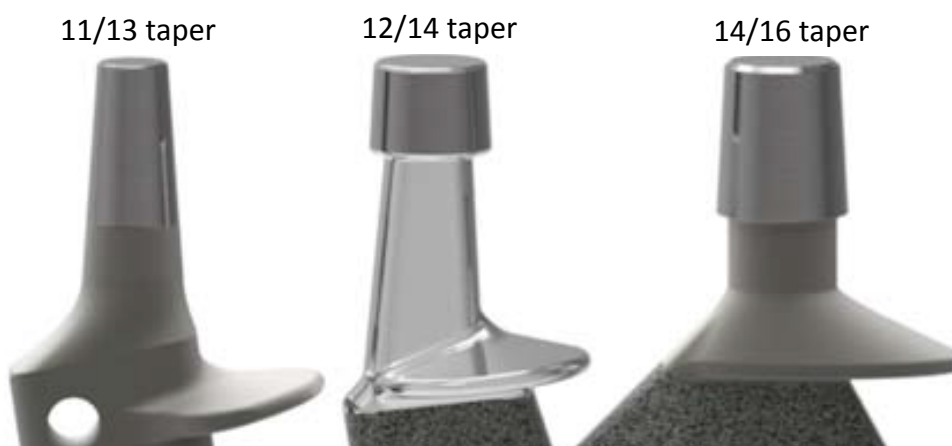
Figure 2-23: Image depicting different taper designs by manufacturers†.

In the last two decades, manufactures have been altering femoral neck tapers from 11/13 to 12/14 to 14/16 (Figure 2-23) with the 12/14 taper being the most popular.

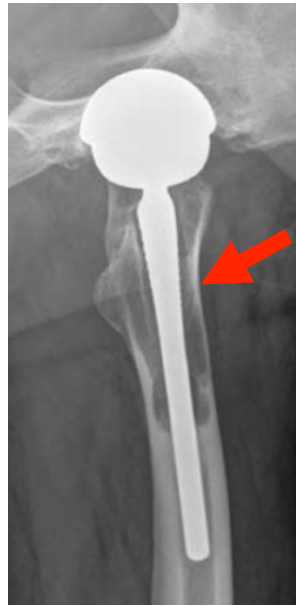
Figure 2-26: Lateral radiograph of a MoM THR demonstrating progressive proximal osteolysis (arrow)*.
